MARINE SAFETY INVESTIGATION
REPORT 182

Independent investigation into the grounding of the
Greek registered ship

Doric Chariot

at Piper Reef, North Queensland
on 29 July 2002

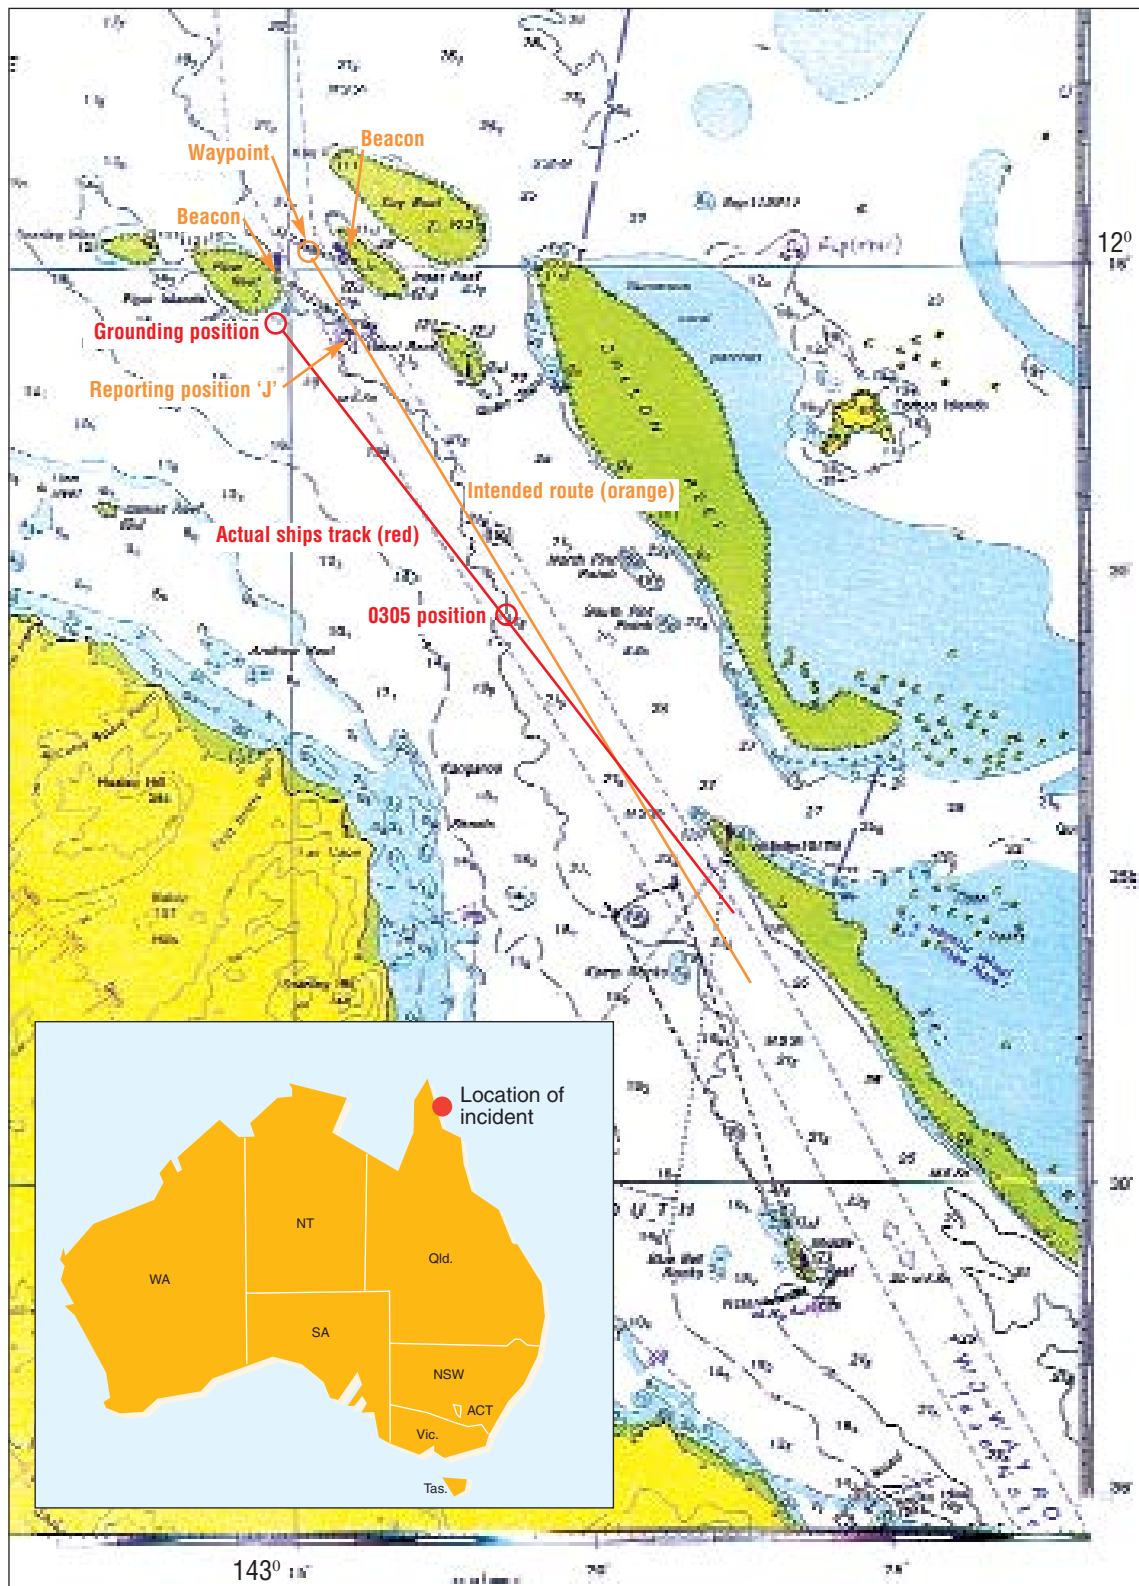
FIGURE 3:
Portion of chart Aus 835 showing grounding position

Doric Chariot grounded at about 0335, 0.52 miles south from Piper Reef light beacon on a heading of 343°(G), in position 12° 15.593'S 143° 15.038' E by the ship's GPS. The high water at Piper Reef was at 0001 at a predicted height of 2.3 m and the next low water was at 0741. The tide at Piper Reef had been ebbing for about 3½ hours.

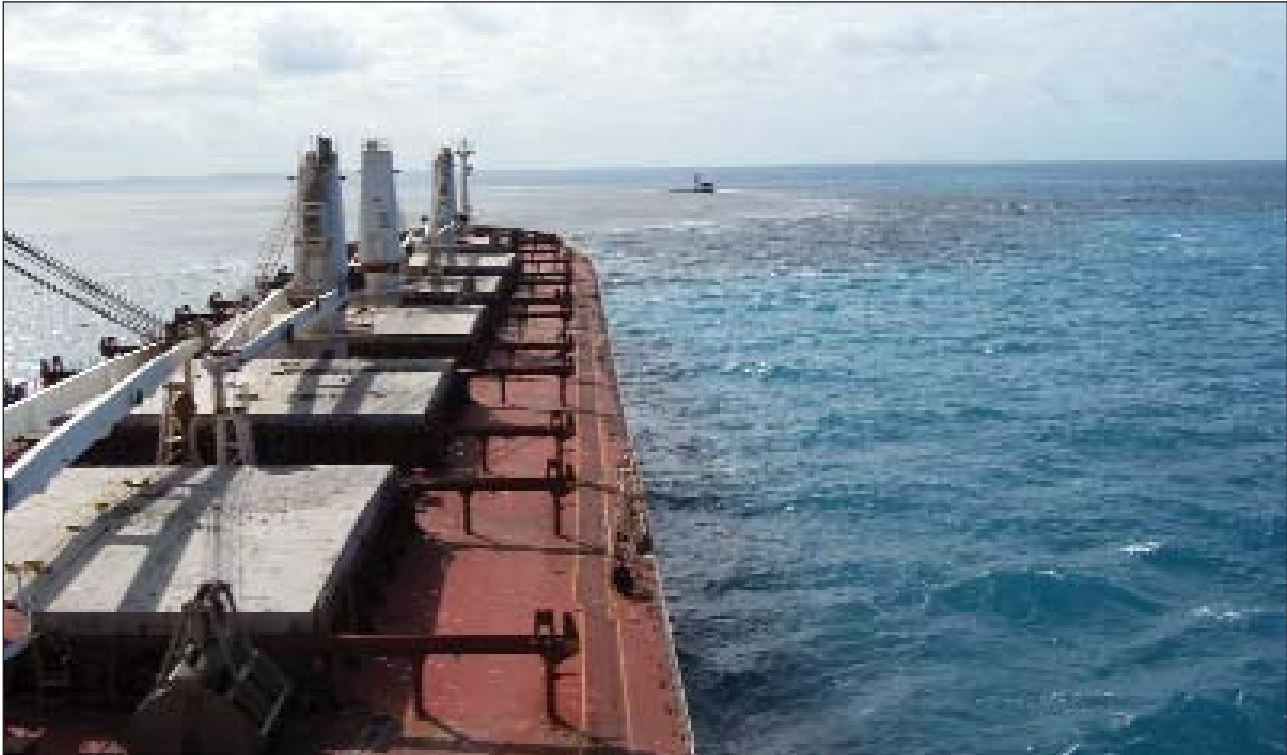
FIGURE 4:
Photograph taken from starboard bridgewing of *Doric Chariot* with Piper Reef light beacon in the distance

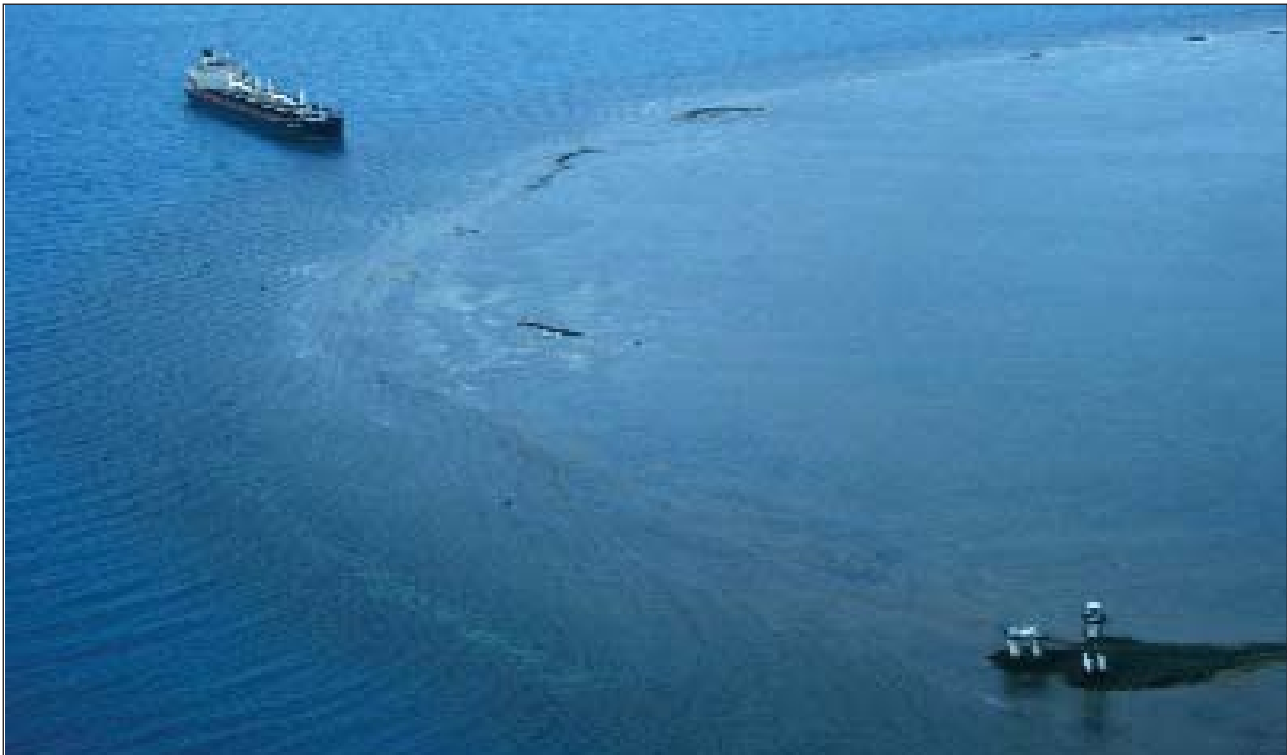
FIGURE 5:
Aerial photograph of *Doric Chariot* aground with Piper Reef beacon in the foreground

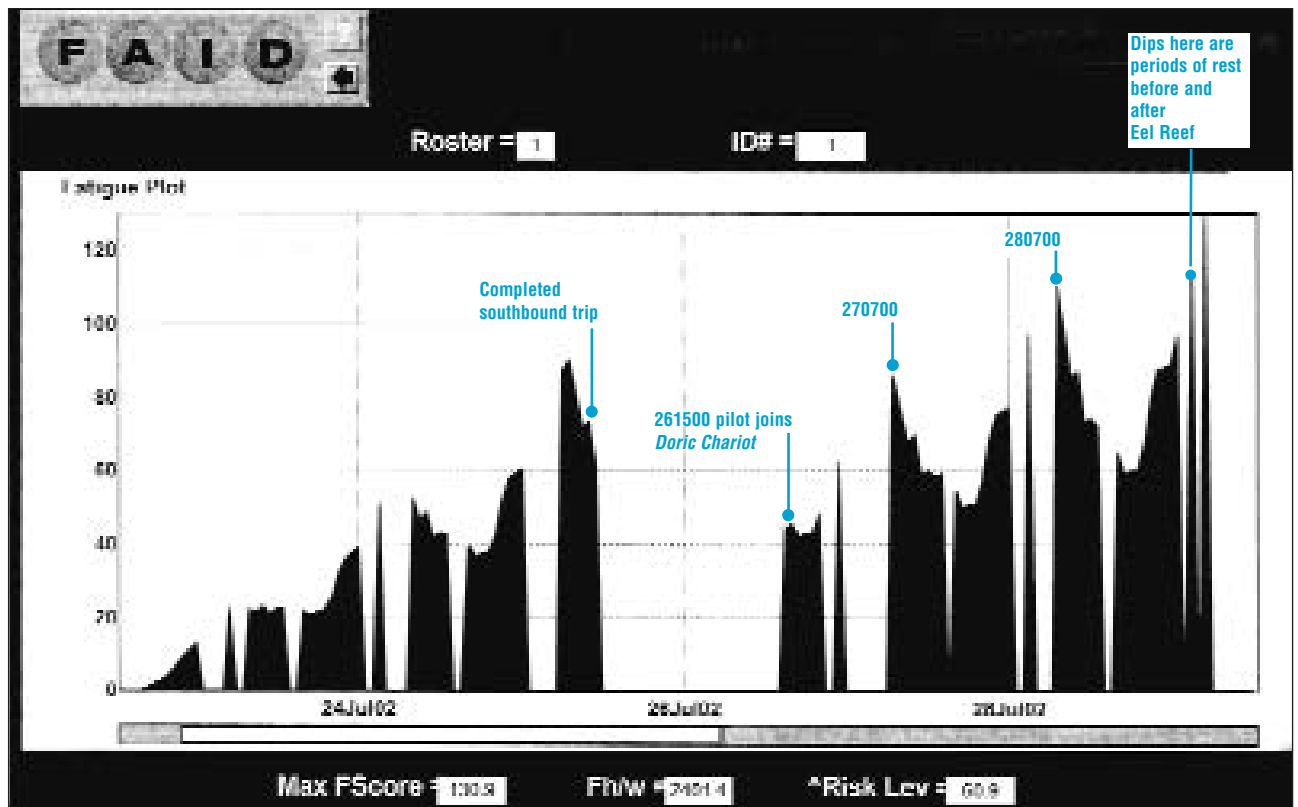
FIGURE 7:
The best case

To examine the pilot's fatigue using FAID a 'best' and 'worst' case scenario was adopted. The best case uses only the hours of actual work on the bridge as the input whereas the worst case uses all the waking hours as the input parameters. The 'true' score probably lies somewhere between these two extremes.
